Addressing Out of Date Hospital Piping Schematics

**POTABLE WATER PIPING SURVEY/
CROSS CONNECTION CONTROL SURVEY REPORT**

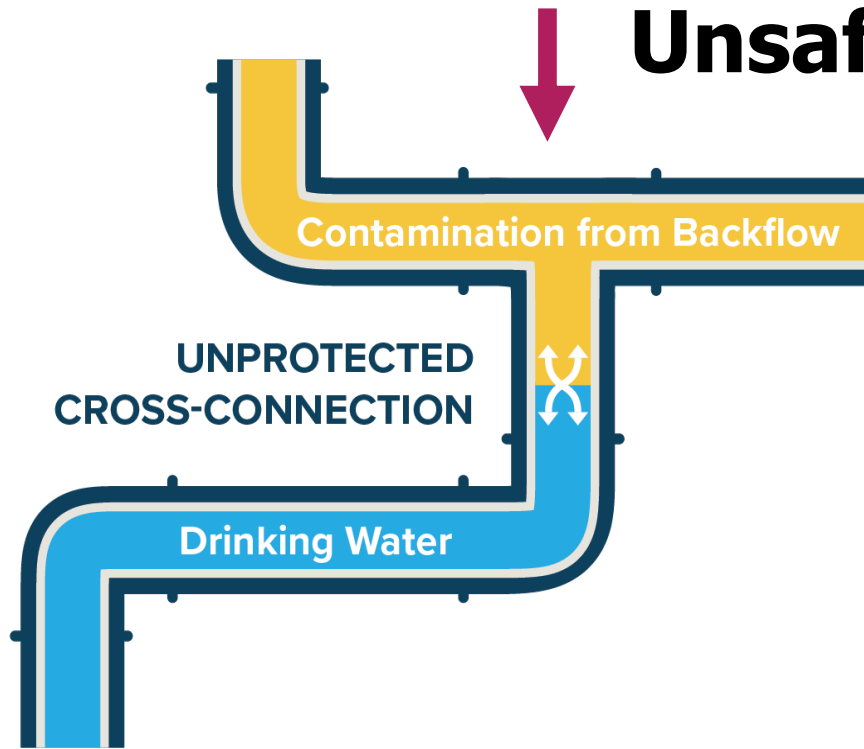
Unsafe Cross-Connections

-Wrong type of backflow preventer
-Leaking indicates malfunction
-False sense of protection

- Unsafe cross-connection to Potable Water
- Medical facility built in 1993
- 27 additional cross-connections
- Facility averted potential contamination

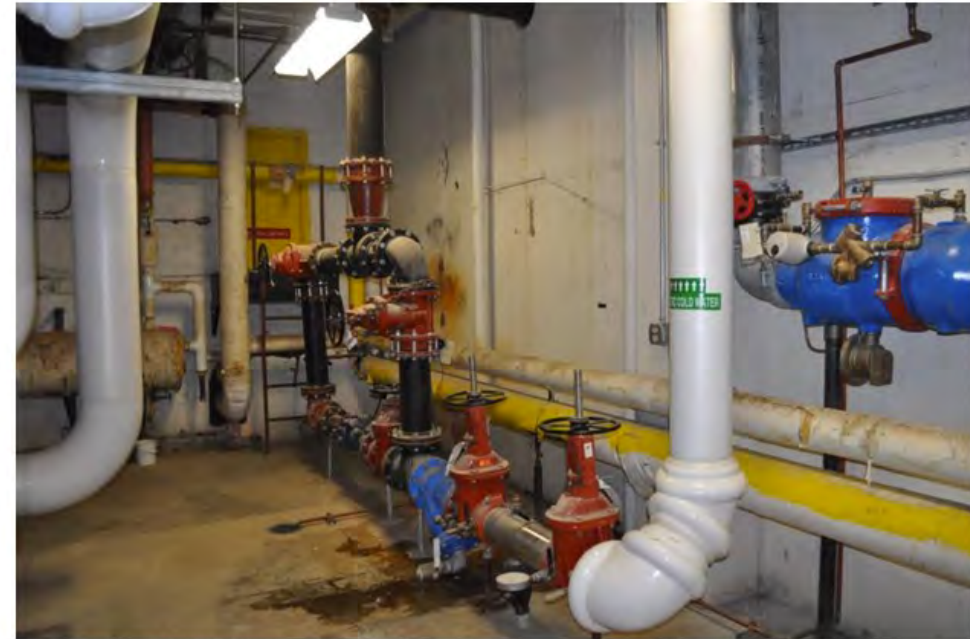
Fig 1. Building Containment - protects upstream public water supply from building domestic water and fire protection water (Not Organization Facility).

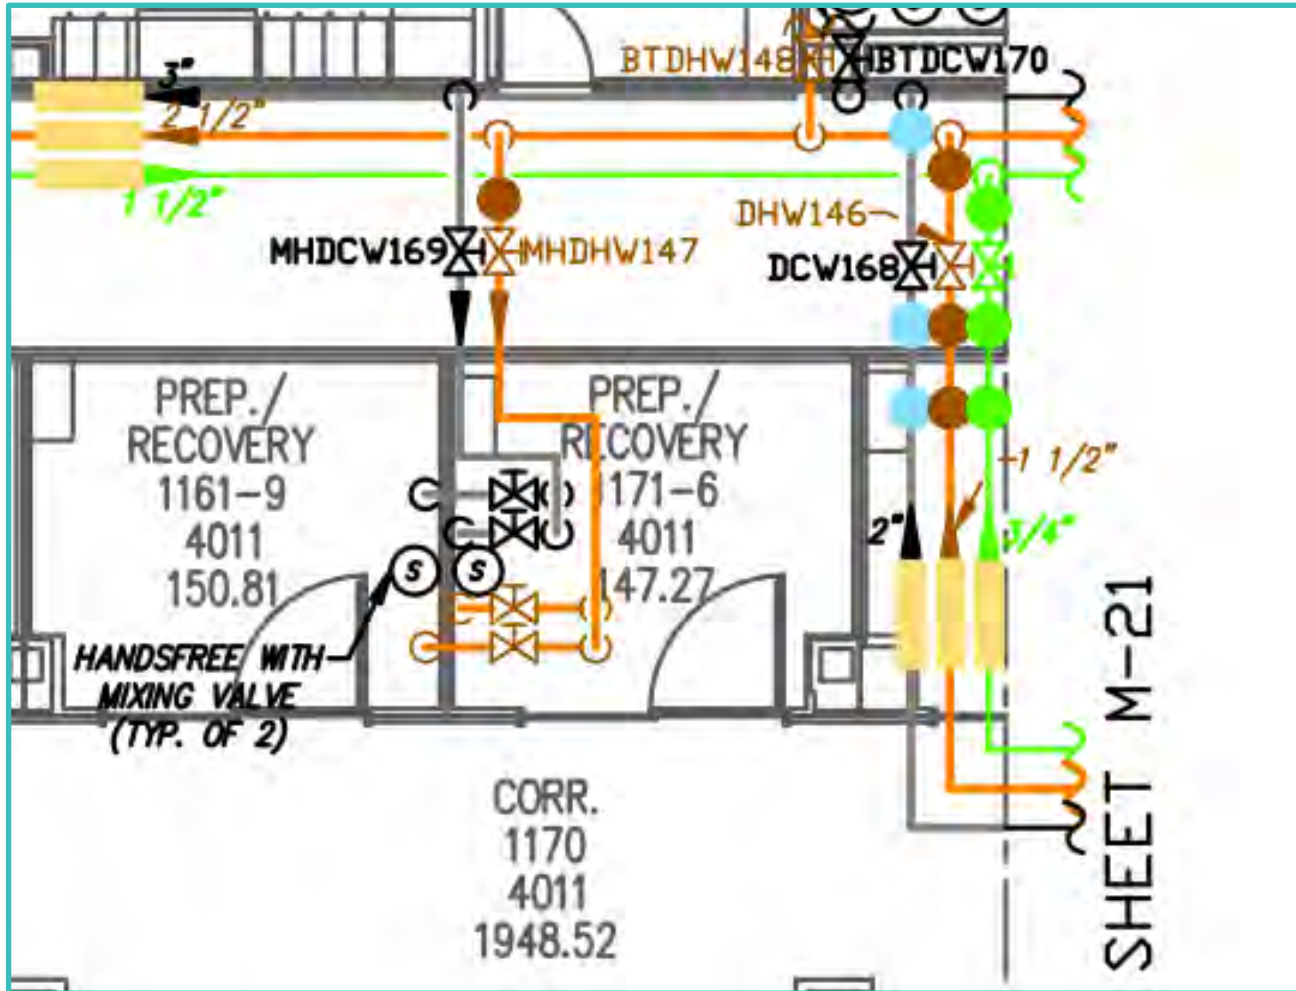
- Color Coded
- System Flow Directions
- Existing/Missing Label Locations
- Valve Tag Reference, Labeling
- Pipe Size
- Room Number/Location
- Customizable Findings

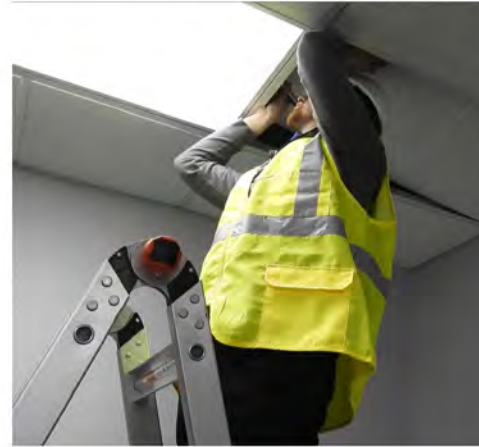
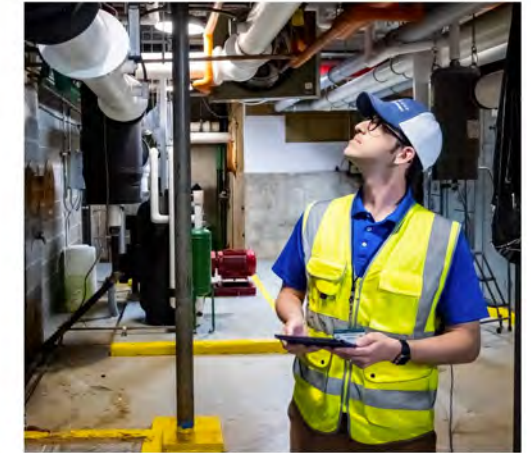
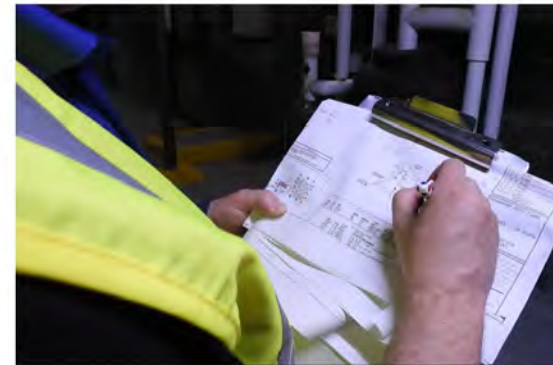
Create the Path to Reliable Piping Schematics

- Visual onsite survey
- Utilizing existing drawings/legacy knowledge
- Captures existing conditions

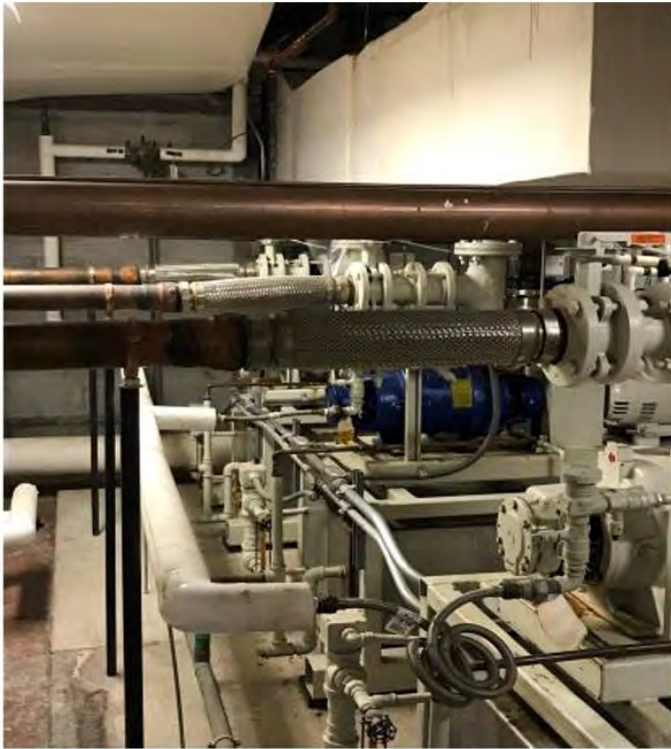
RPBP in Common Supply - Medical Vacuum Pumps.

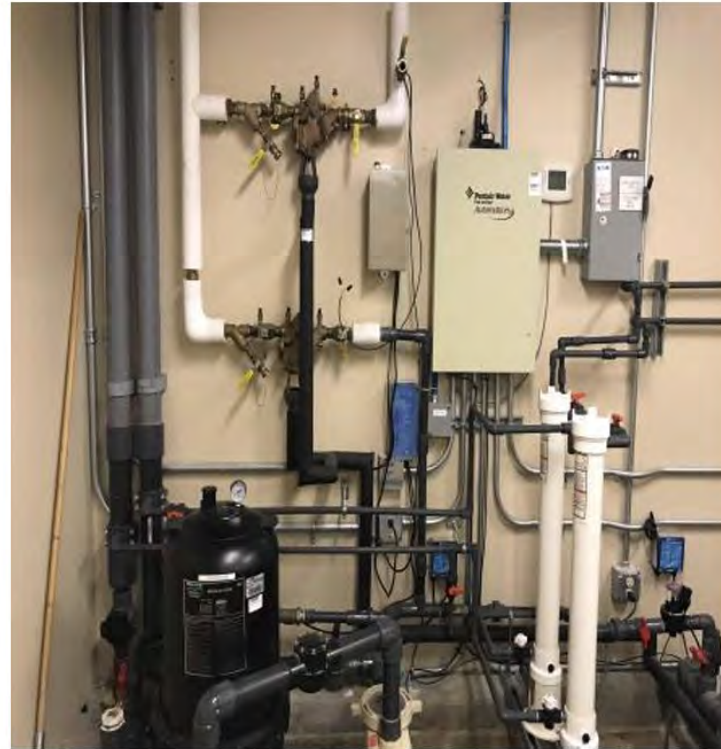
RPBP-Supplies to Irrigation System and Dec. Fountain.
